Figure 4.3.6-3. Total Halogenated Hydrocarbons in Groundwater (ug/L) and Estimated Well Yields, Building 25A Lobe Old Town Groundwater Solvent Plume.

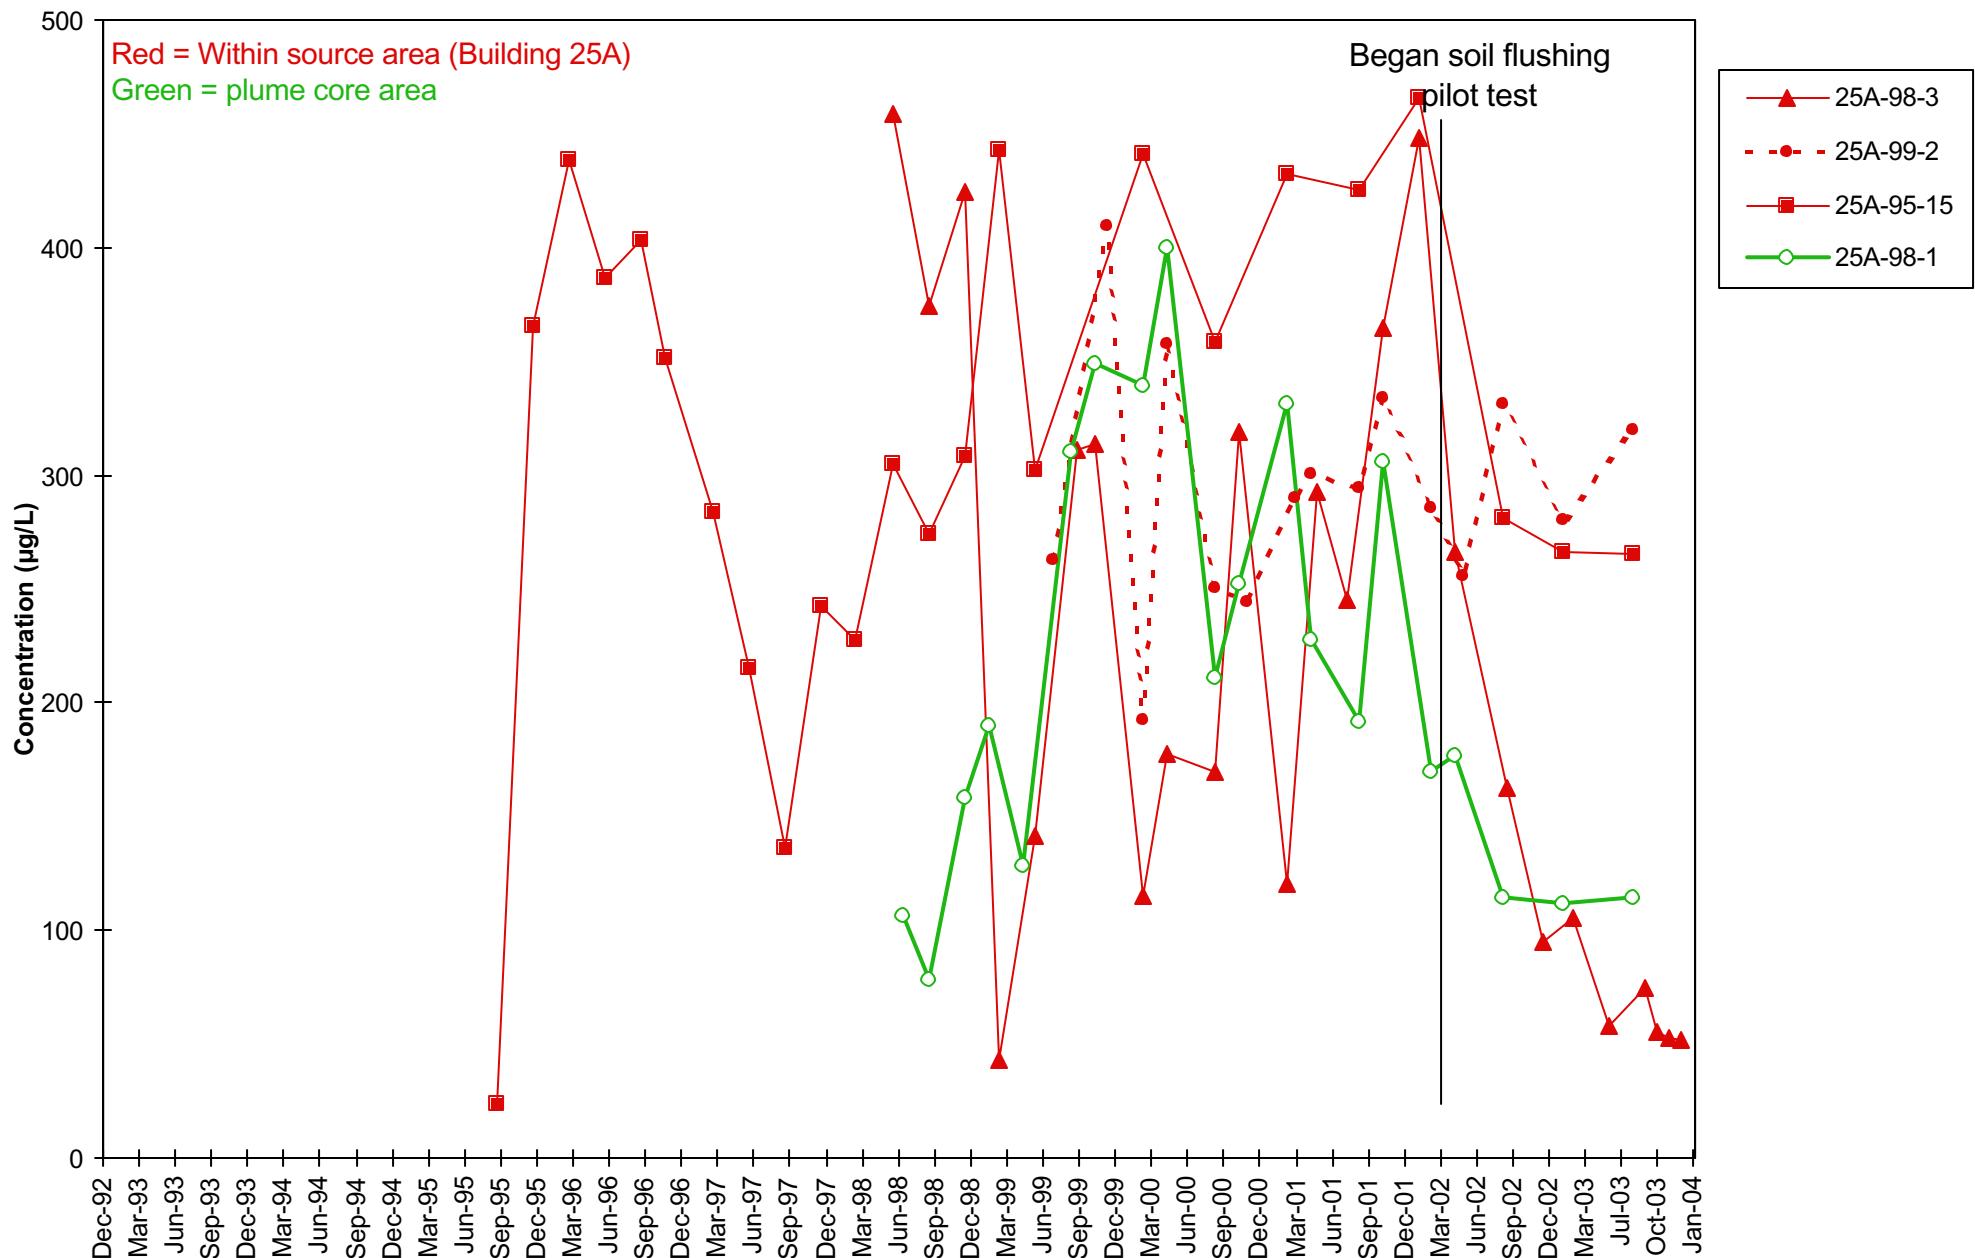
Figure 4.3.6-4a. Concentration Trends for Total Halogenated VOCs in Source and Core Area Wells Within the Old Town Solvent Plume (Building 25A Lobe)

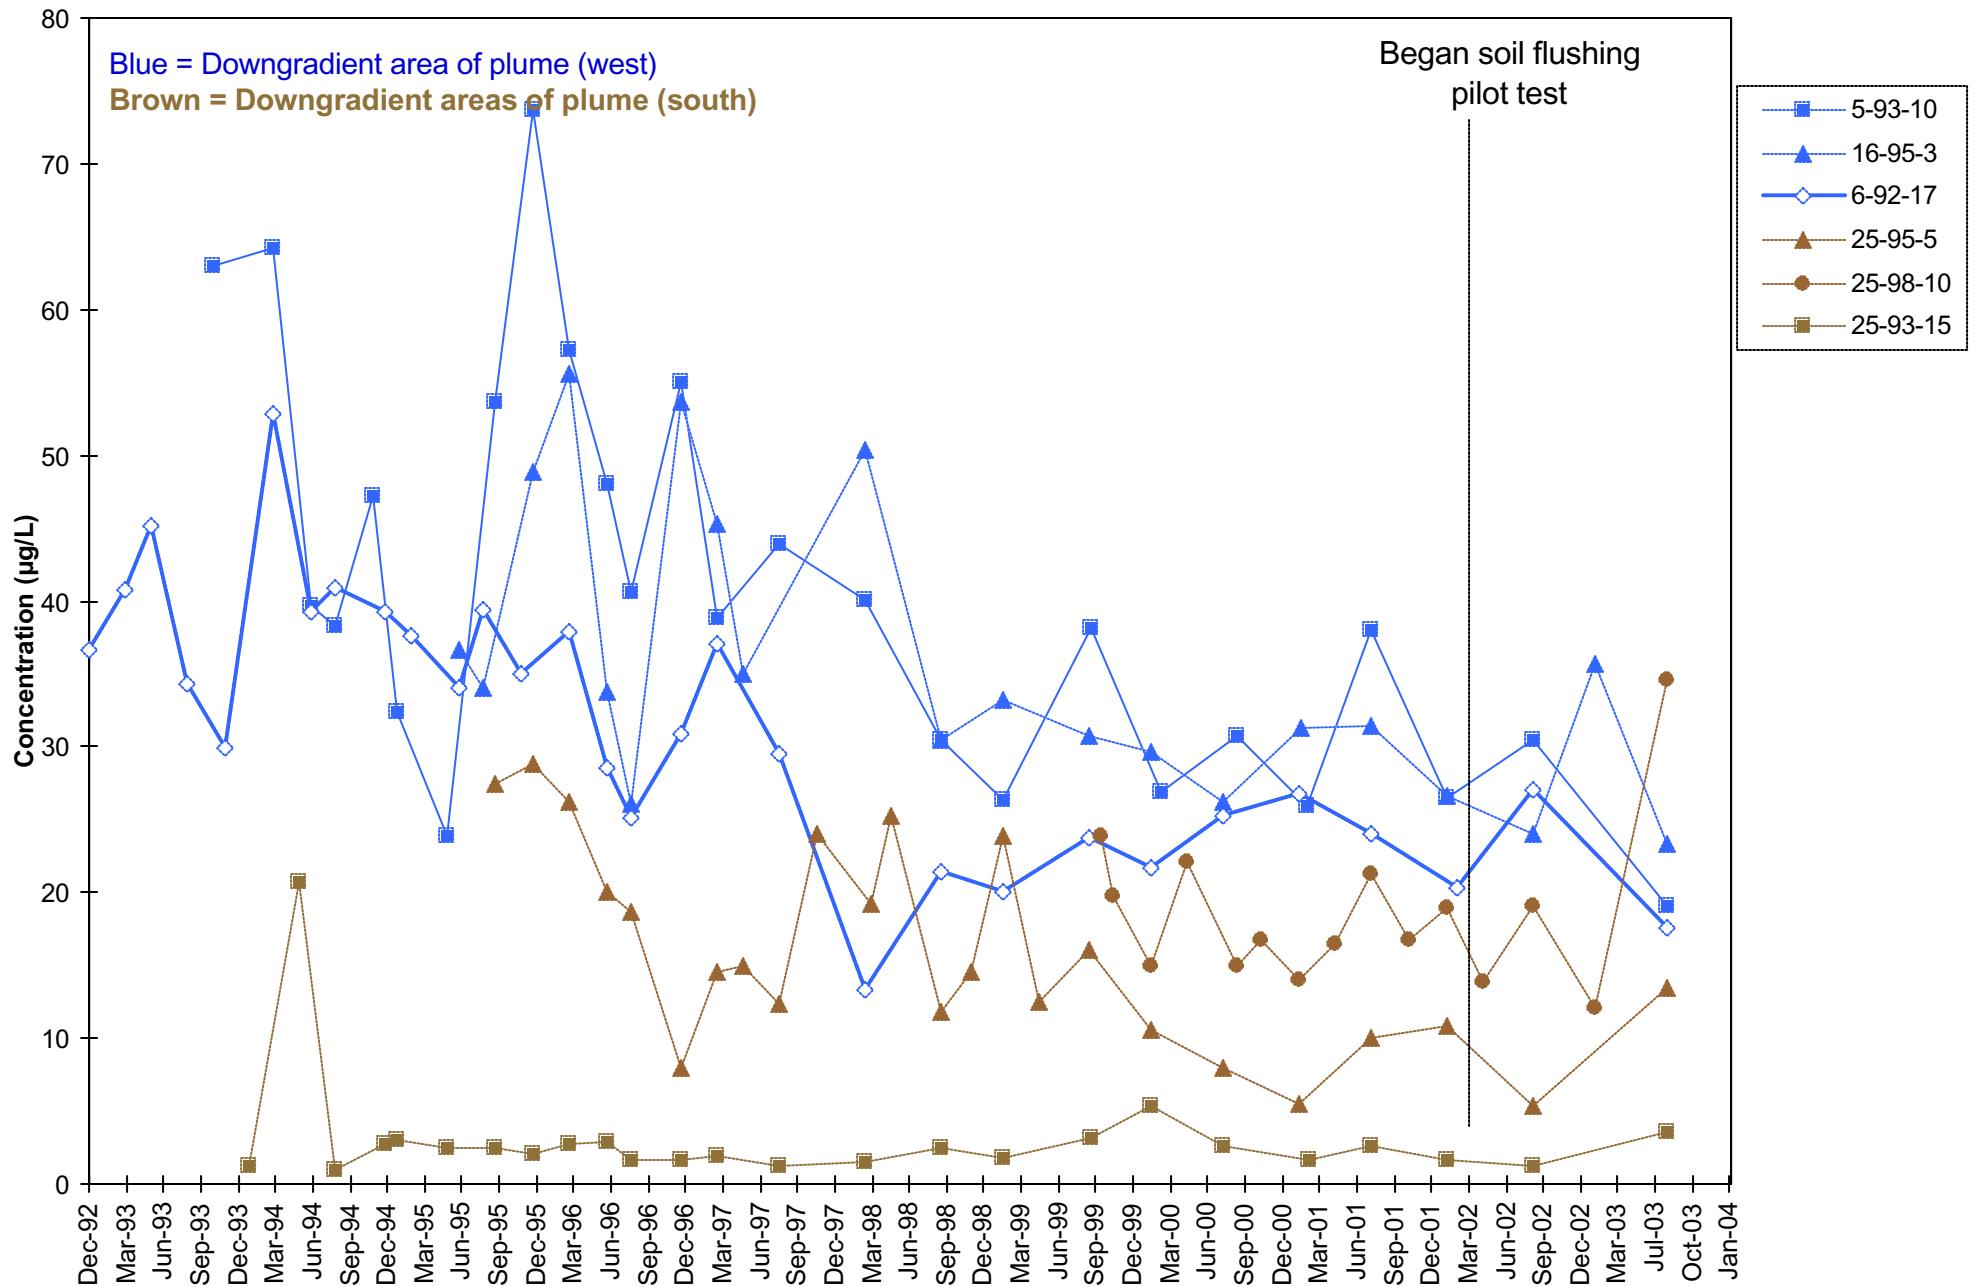
Figure 4.3.6-4b. Concentration Trends for Total Halogenated VOCs in Wells Within the Downgradient Portion of the Old Town Solvent Plume (Building 25A Lobe)

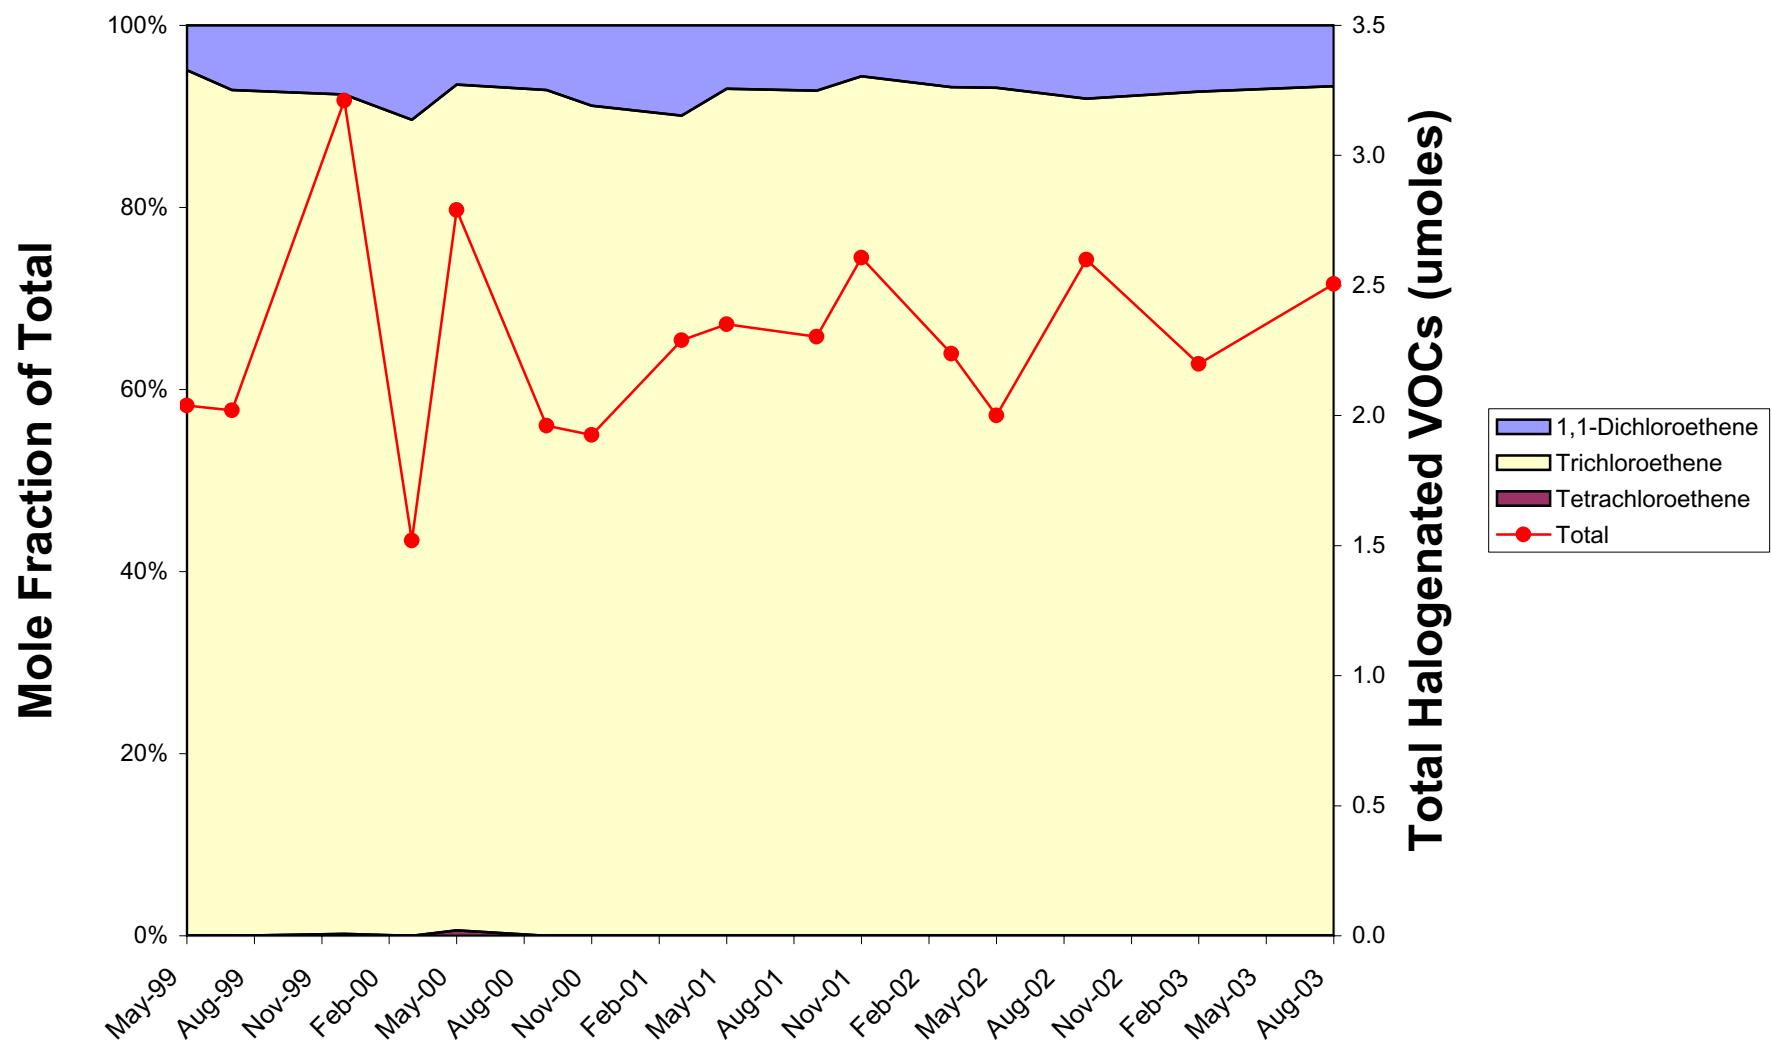
MW25A-99-2

Figure 4.3.6-5. Temporal Variations in Halogenated Non-aromatic VOC Concentrations in Well MW25A-99-2, Building 25A Lobe

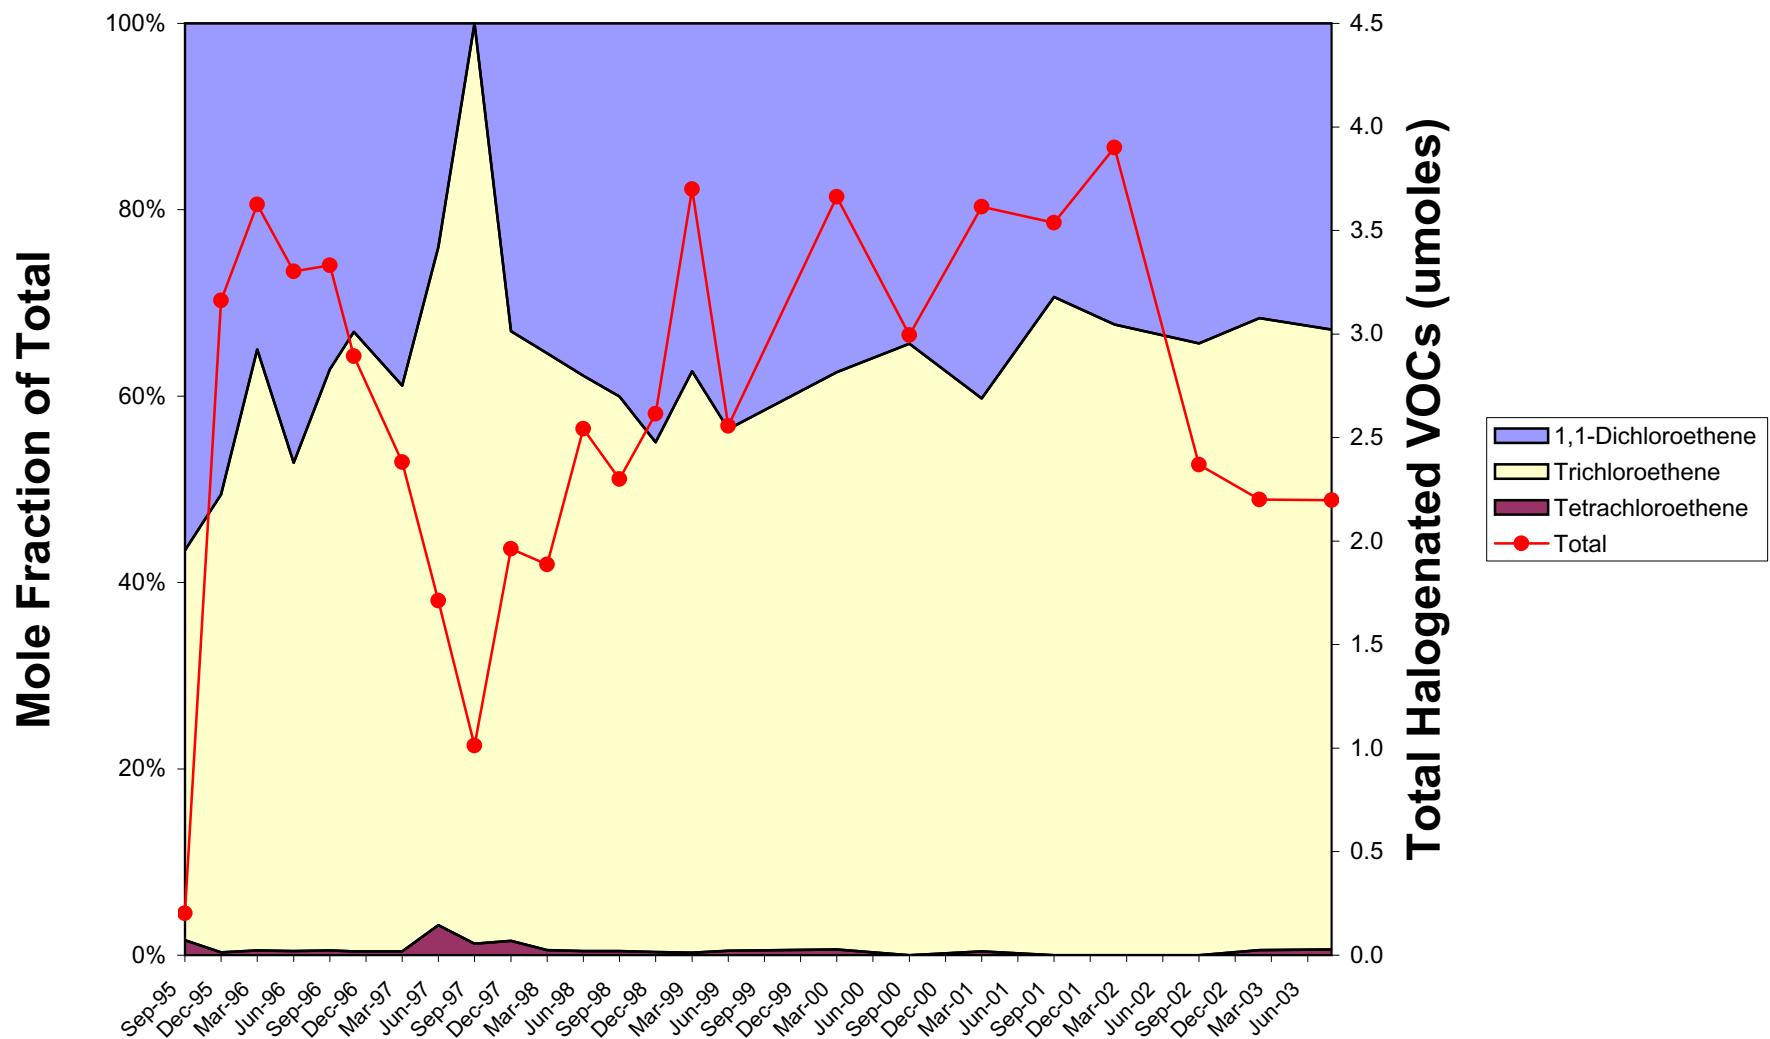
MW25A-95-15

Figure 4.3.6-6. Temporal Variations in Halogenated Non-aromatic VOC concentrations in Well MW25A-95-15, Building 25A Lobe

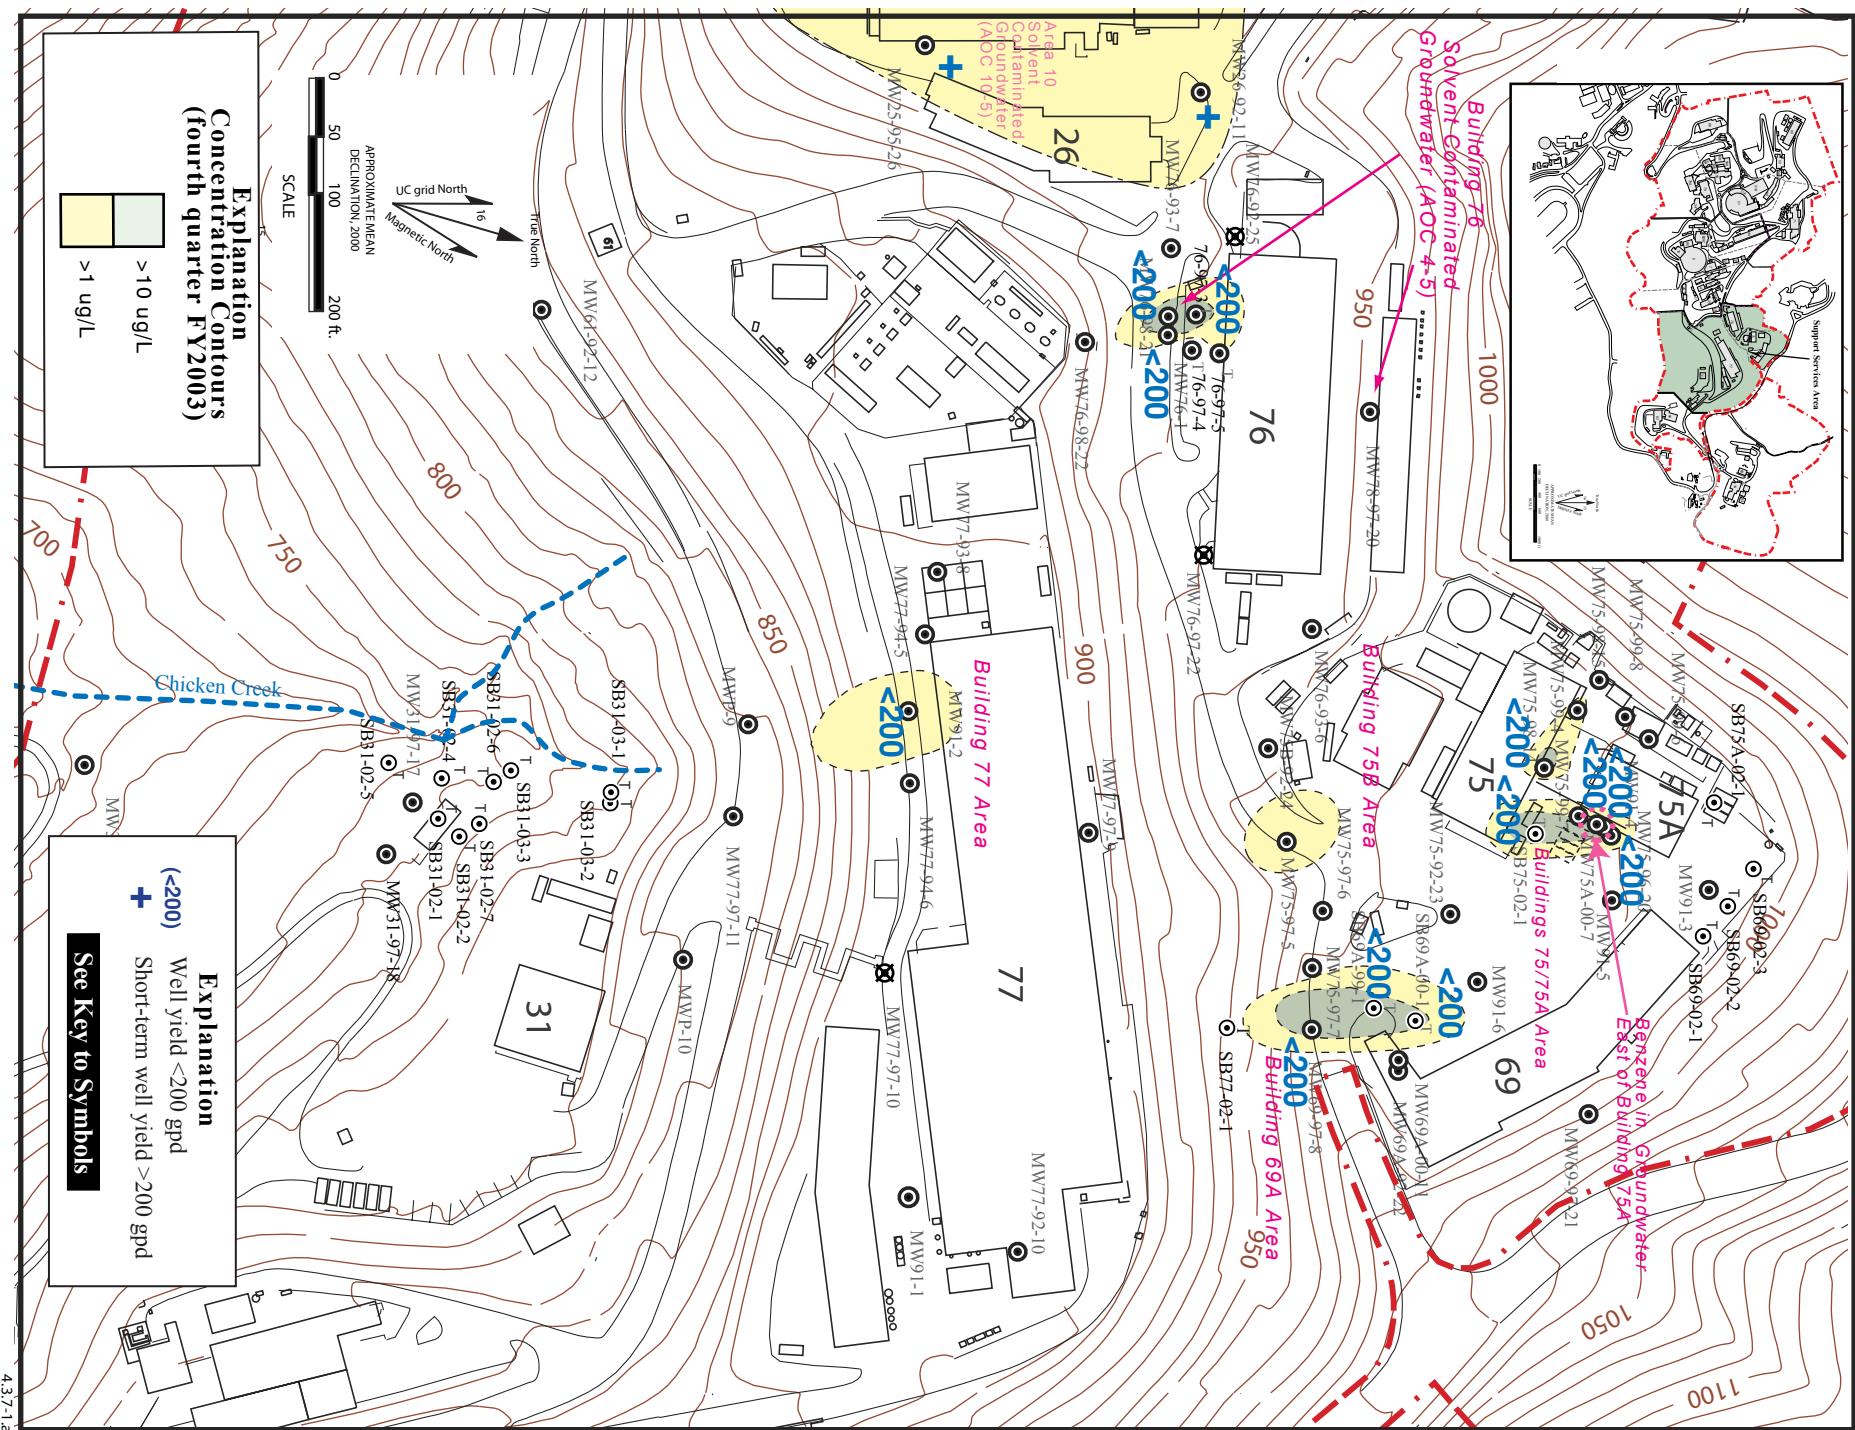
Figure 4.3.7-1. Total Halogenated Hydrocarbons in Groundwater and Estimated Well Yield in the Support Services Area.

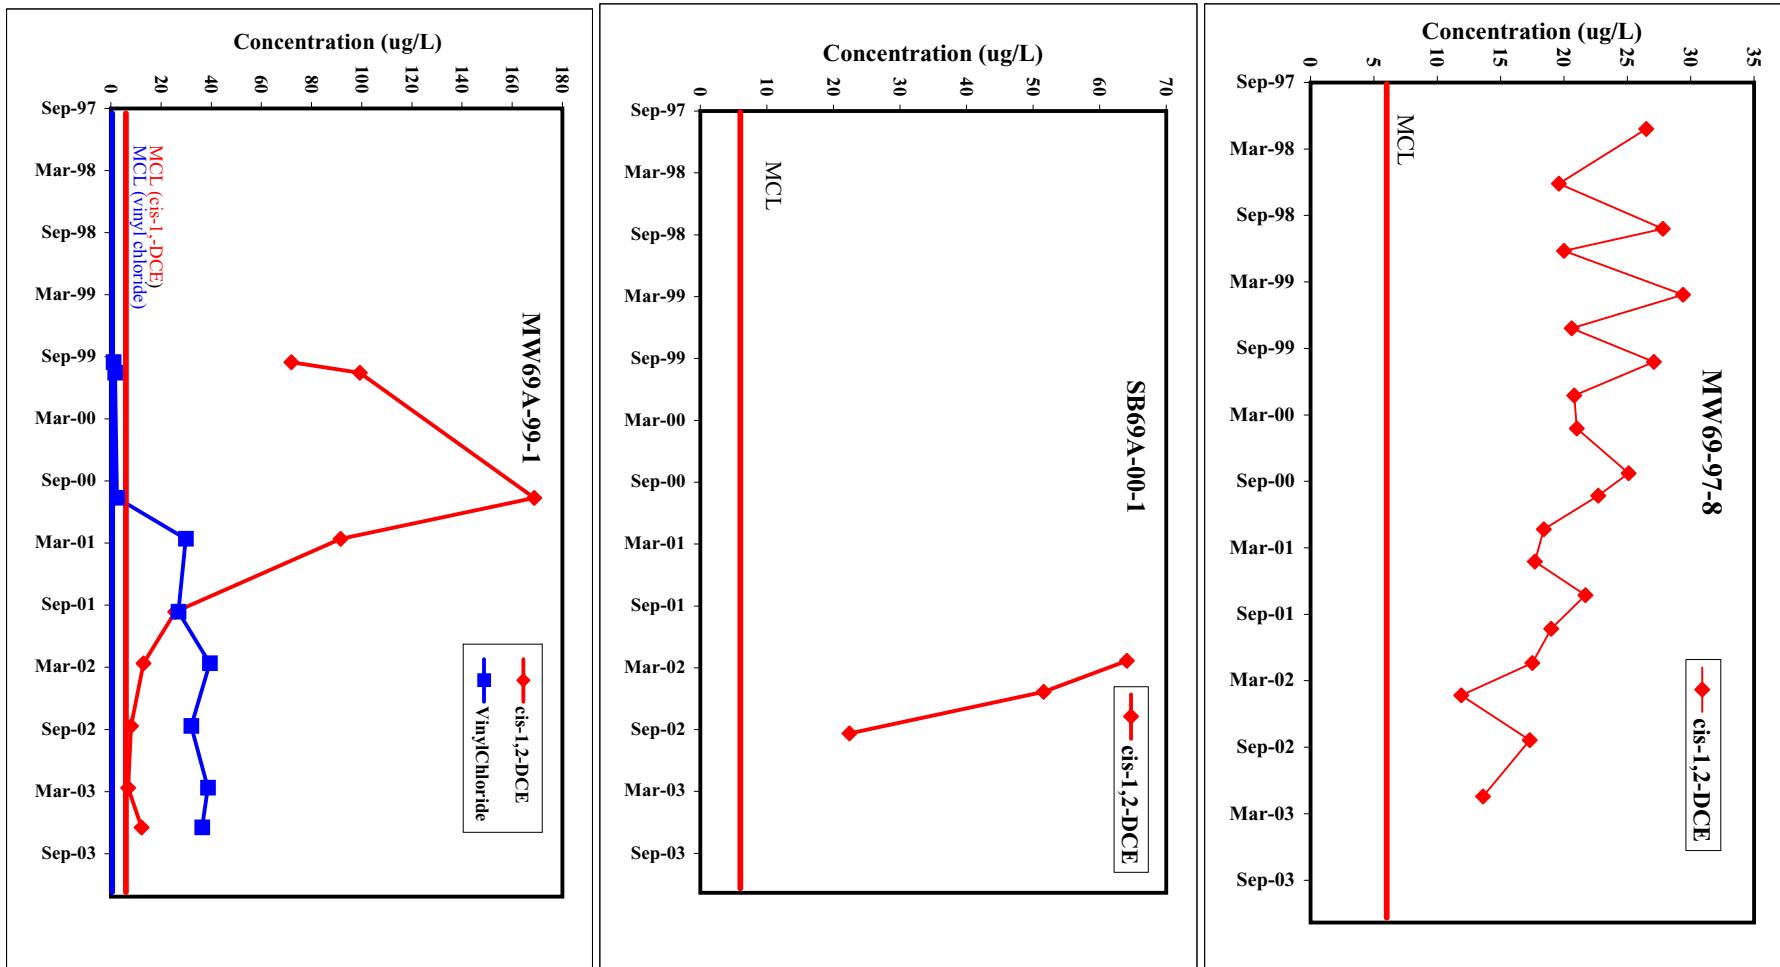
Figure 4.3.7-2. Variations in Concentrations of Halogenated Hydrocarbons Detected in MW69-97-8, MW69A-00-1, and MW69-99-1.

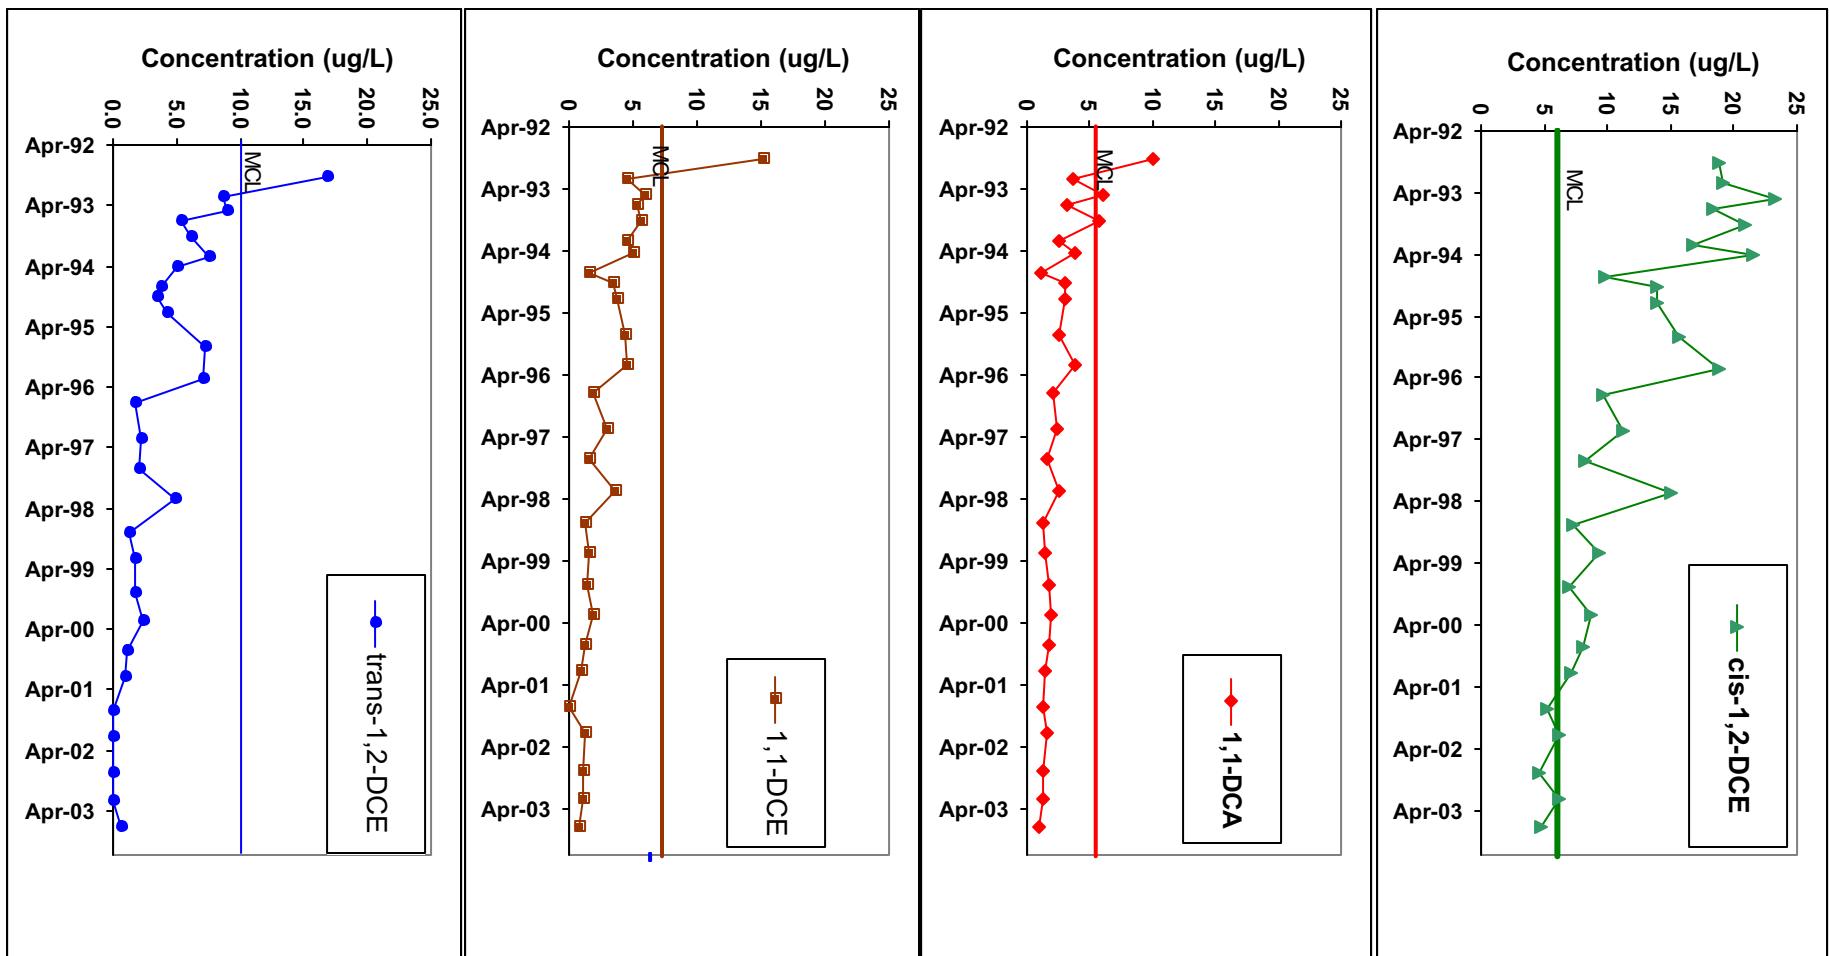
Figure 4.3.9-1. Variations in Concentrations of Halogenated Hydrocarbons Detected in MW91-2.

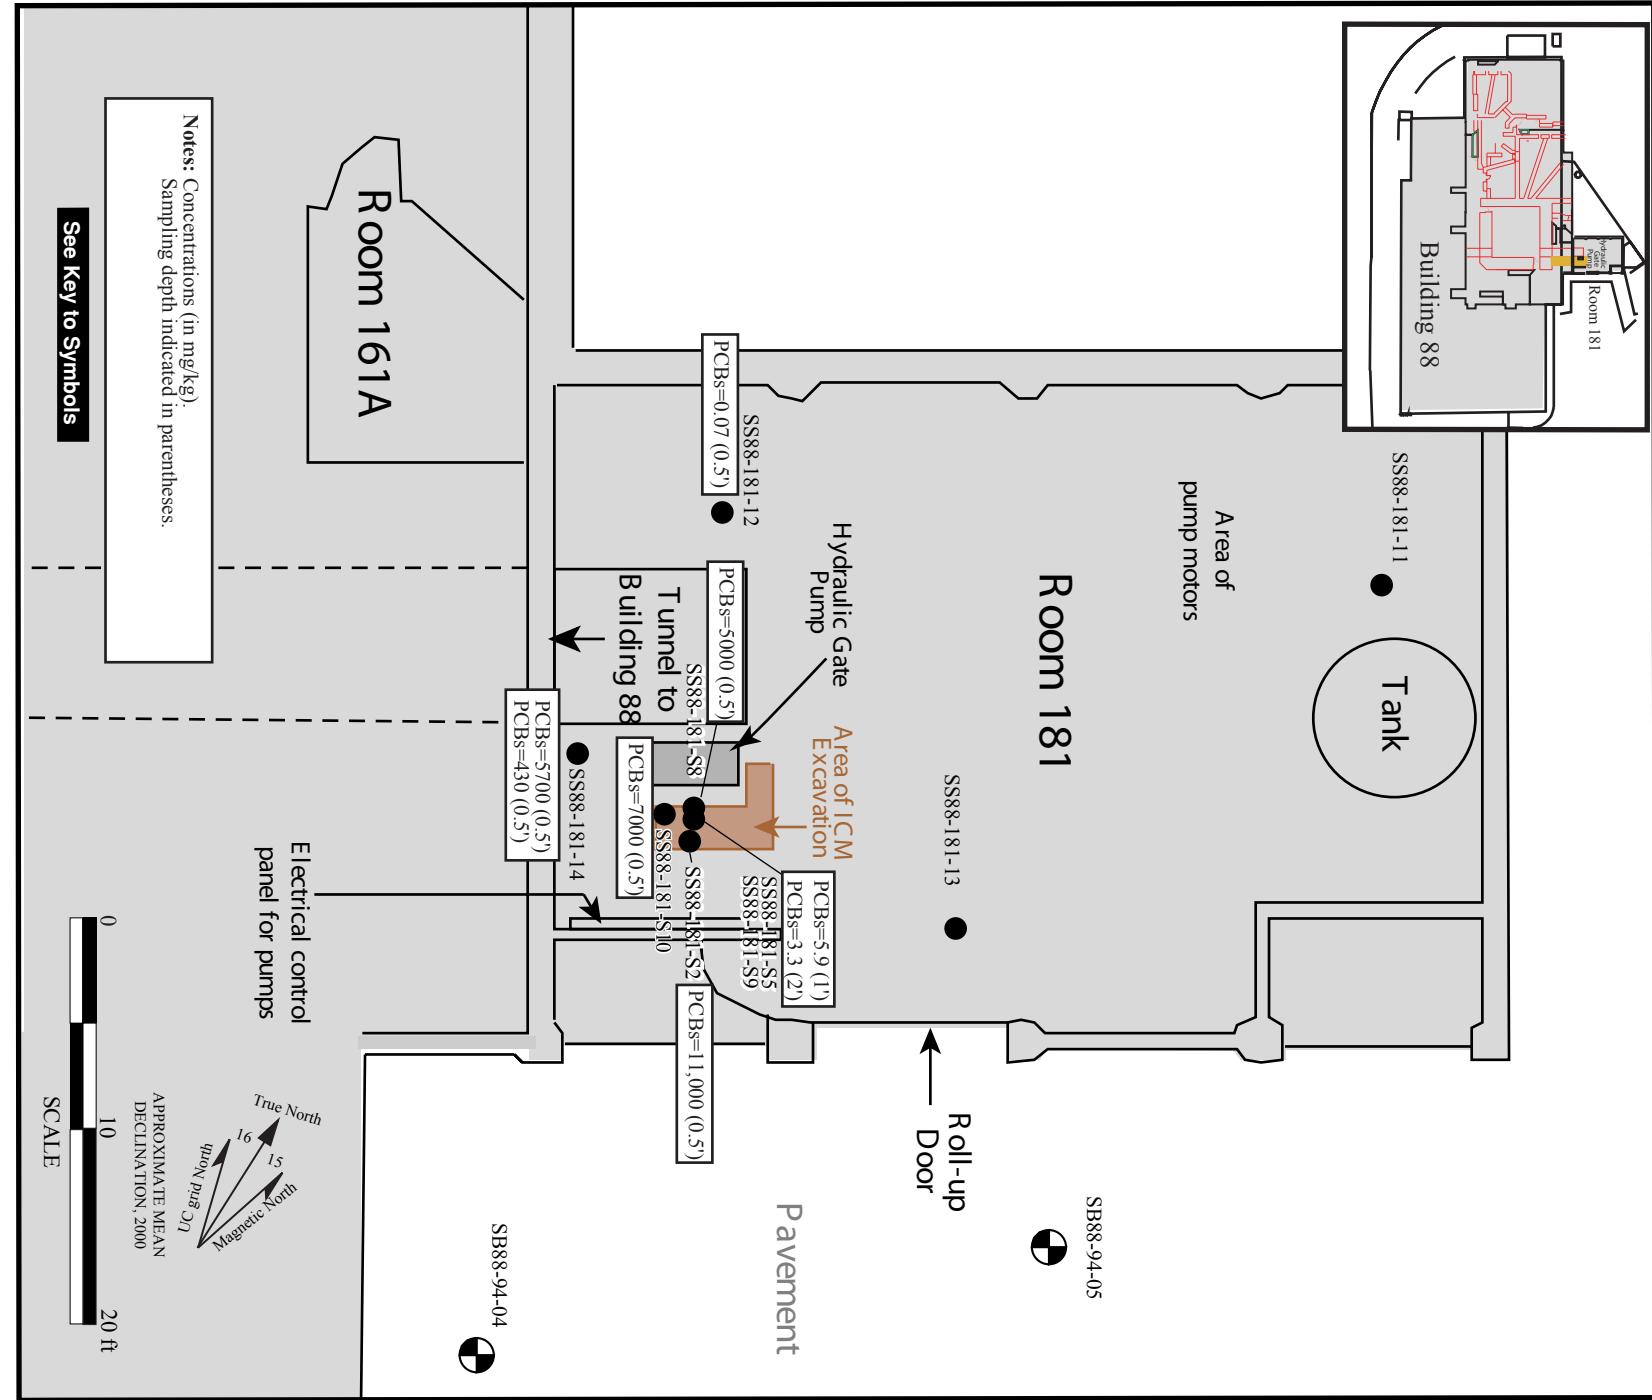
Figure 5.3-1. Building 88 Hydraulic Gate Unit (AOC 6-3) Showing Residual Concentration of PCBs in Soil after 1995 ICM.

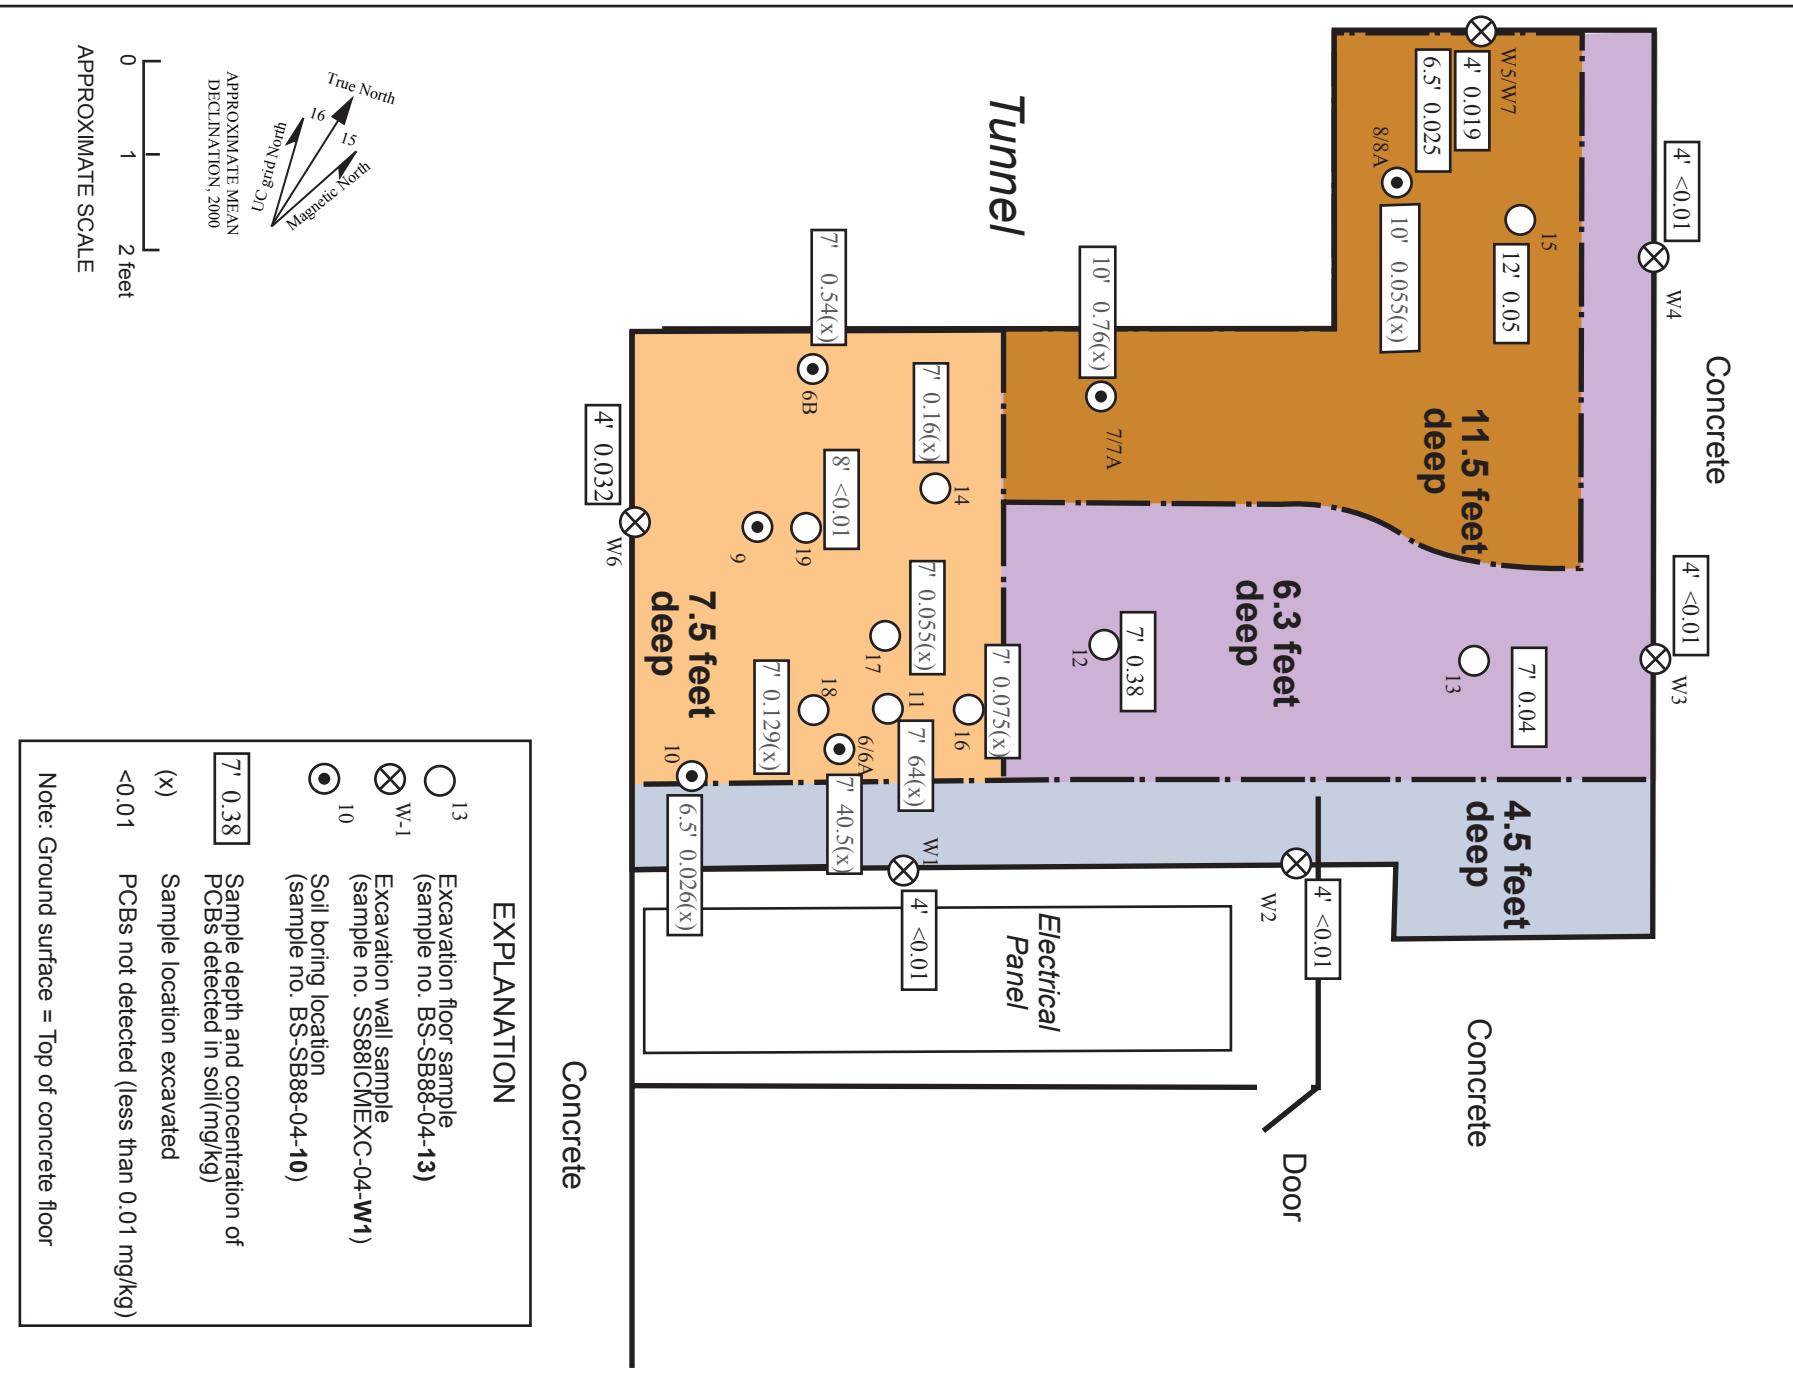
Figure 5.3-2. Building 88 ICM Excavation, Confirmation Soil Sample Results.

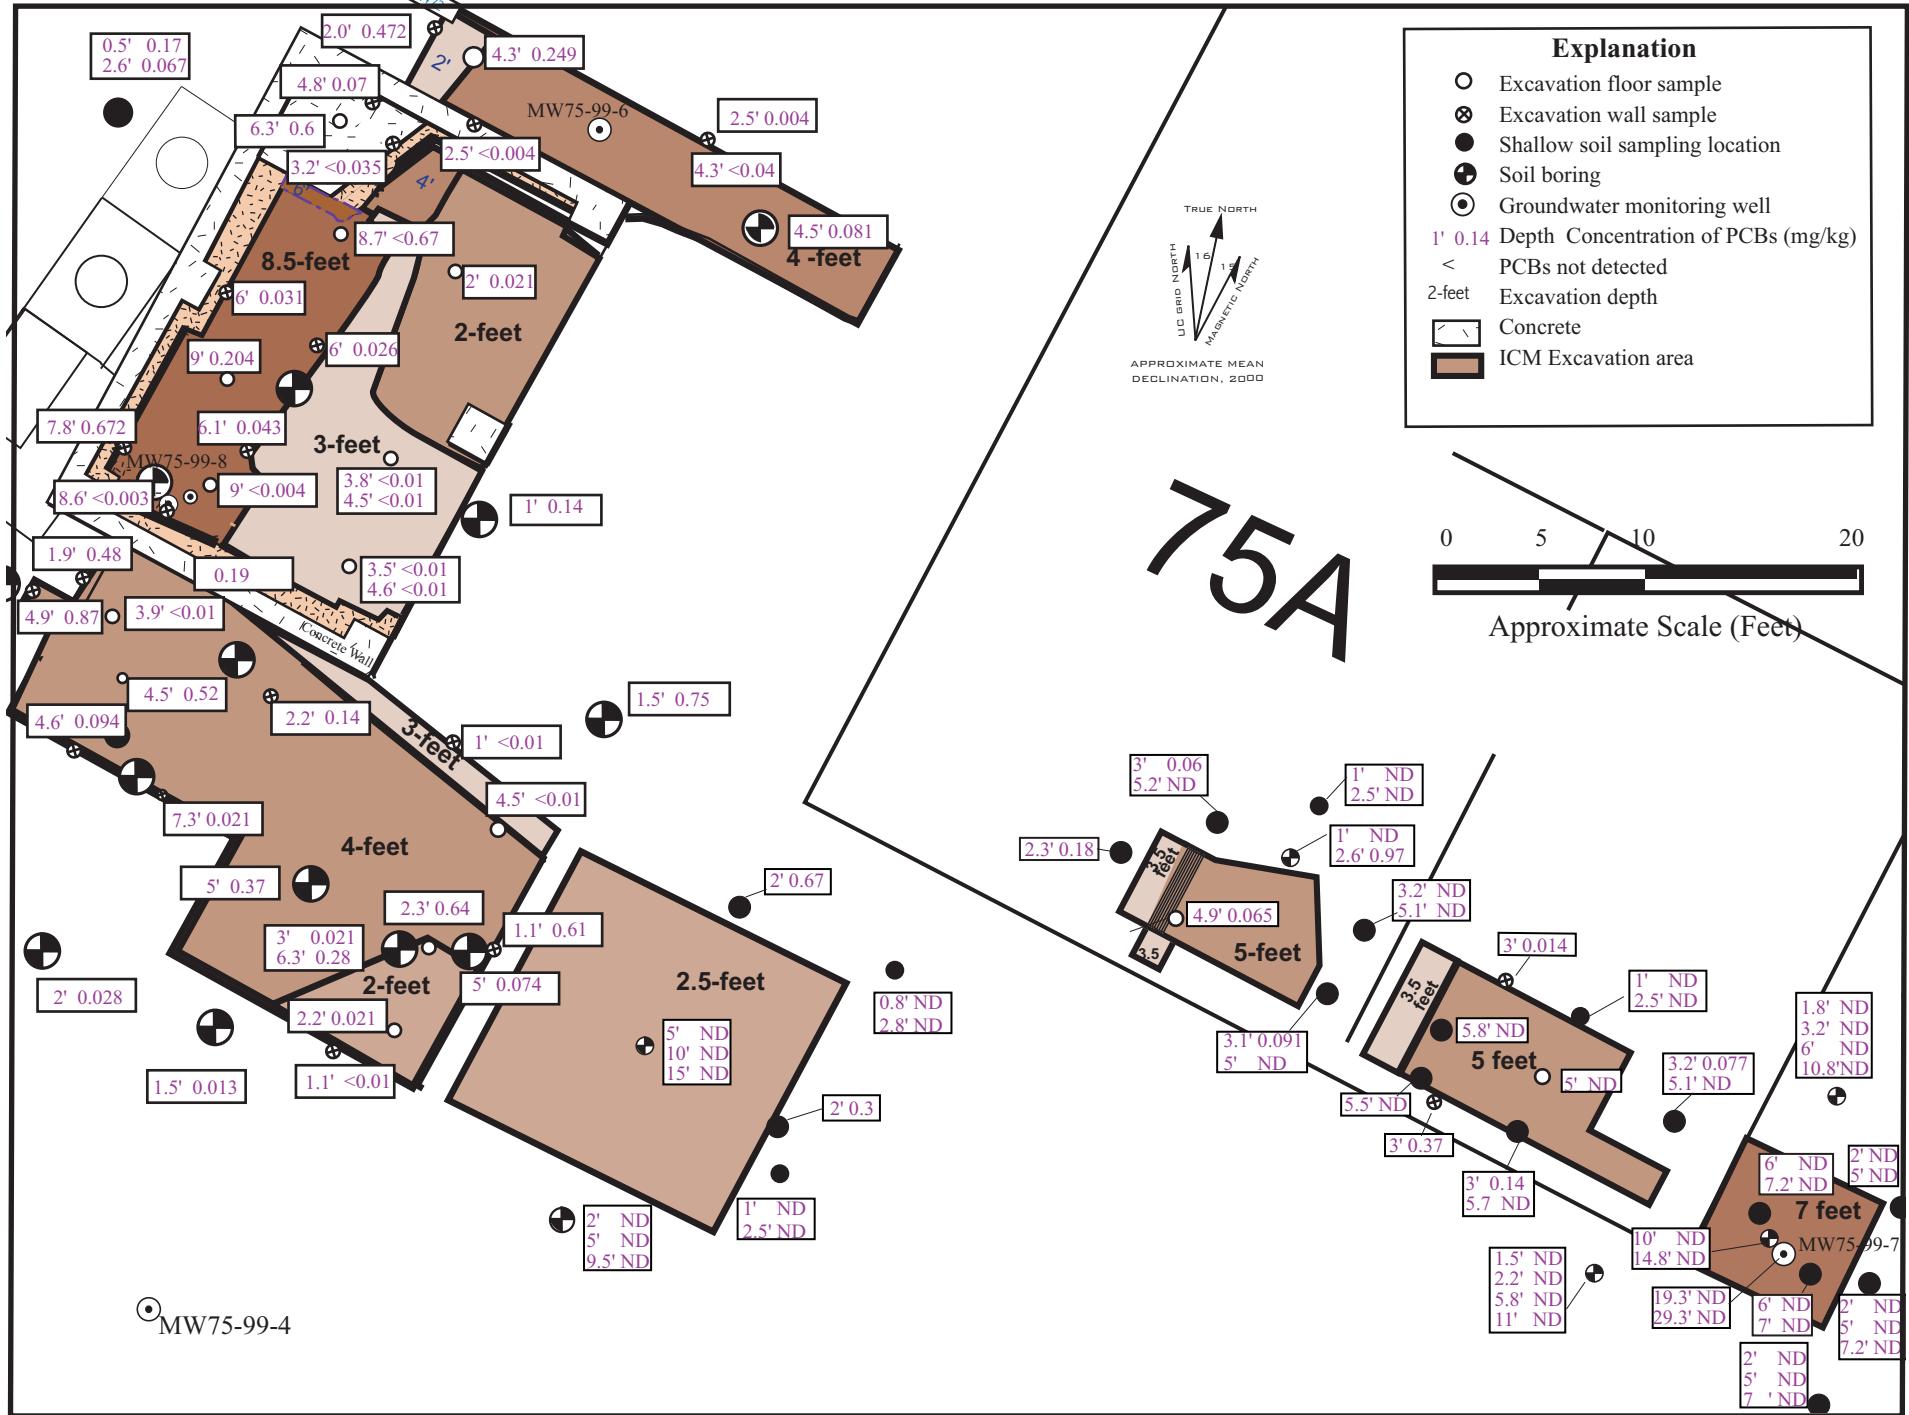
Figure 5.4-1. Building 75/75A ICM Area, PCB Concentrations in Confirmation Samples.
